Evaluation of Cracking in Pre-service and In-service Snow Plow Carbide Wear Surfaces

Research Investigation RI 01-023

Research Number RDT 03-015

Missouri Department of Transportation

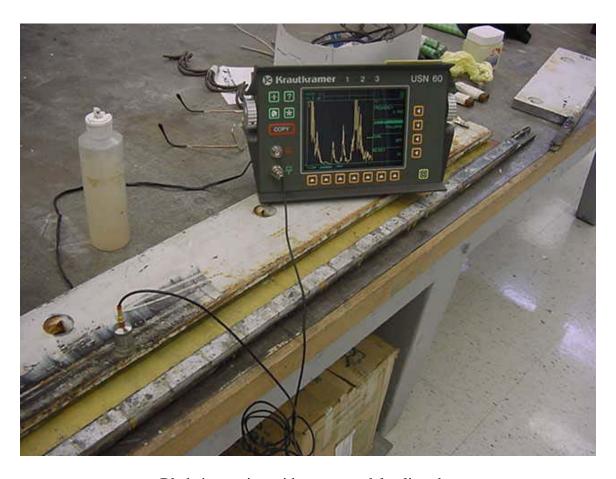
Blade inspection with a contact delay line shoe

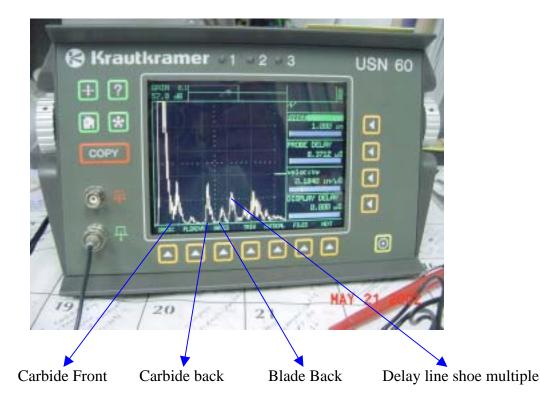
The first multiple of the shoe comes up at 1", but since the part thickness is .75", that is not a problem. The first in-product interface (steel/carbide) comes up at about .2", the second interface (carbide/steel), comes up at about .45", with the part back at .7". There is a delay line shoe multiple on the CRT outside the area of interest within the carbide that could confuse inexperienced inspectors, but which is otherwise not a problem on the single insert blades but could mask indications on the newer double insert blades, unless a longer delay line shoe is used. Cracking in the carbide seems to be gross in nature so reflected signals from such a defect should be easily discernable to a trained individual. Many cracks within the insert are not oriented for adequate detection through reflection,

but such indications cause a loss of back, which will cause the inspector to further evaluate those areas. It was also noted that on the outside steel face of the blade, and within the heat affected brazing zone, many longitudinal cracks varying in length from .25" and 2" were found. These surface indications were verified by penetrant exam, and subsequent analysis shows that they are surface in nature, and extend less than .01" into the product. Since these indications could easily represent a stress riser in an area of the blade that could speed denigration of the wear surface, an inquiry was placed with Kennametal Inc. as to whether heat caused by the milling process could have caused the OD indications, or whether the brazing process was the cause. I also contacted Kennametal Inc. to better understand the dendritics of the carbide and the manufacturing process of the blade.

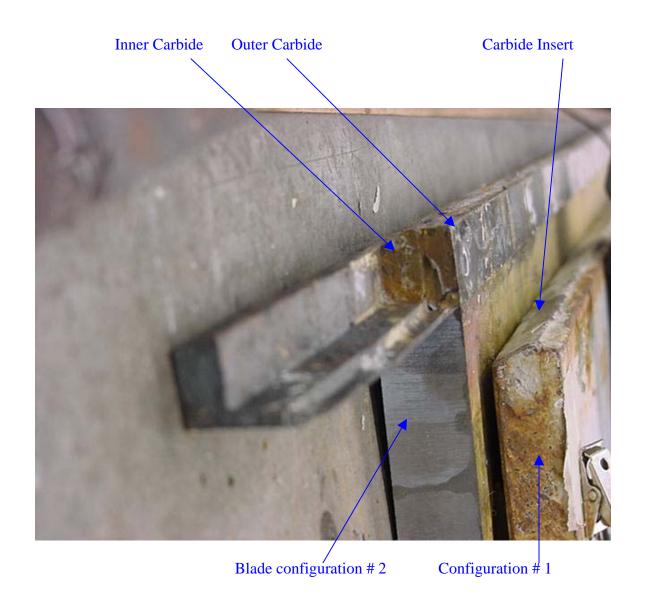
In MoDOT's continuing search for viable products, a number of blades with a different configuration have been purchased for use in a number of districts. The second configuration, shown on page 13, is comprised of two larger carbide inserts brazed together at the front of the cutting edge with only a thin steel edge supporting the back of the inside insert.

These blades are more difficult to inspect because of the sound attenuation between the two carbide inserts at the braze line due to acoustic impedance differences between the harder internal carbide and the lower impedance of the softer outer insert. There is also the additional problem associated with the minimum width and thickness of the steel back in the brazed area and the need for a longer delay line shoe to extend the shoe multiple beyond the inspection zone. This problem is more noticeable in this type of part
